RE: 694 Logan Street Building Application for Demolition Permit

*Property
Condition Assessment
(ASTM E 2018-15)*

*Vacant Building
694 Logan Street
Noblesville, Indiana 46060*

Re: Property Condition Assessment
Vacant Building
694 Logan Street
Noblesville, Indiana 46060
APEC Project No.: 2024-288

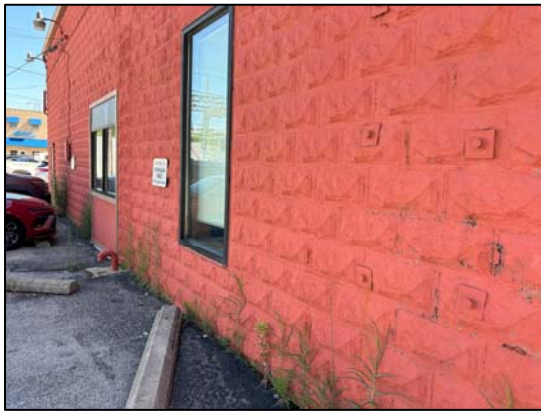
Photo 3: Another view of the southwest corner and wall supports

Recommendations: The exterior concrete block and mortar was observed to be in fair condition, except where the reinforcing wall plates were installed along the southwest, south, and southeast walls. The concrete blocks and mortar were actively cracking, and this is a sign that the building foundation is shifting or moving. It is recommended that a foundation company inspects the foundation integrity to determine whether more support is needed along the exterior wall.

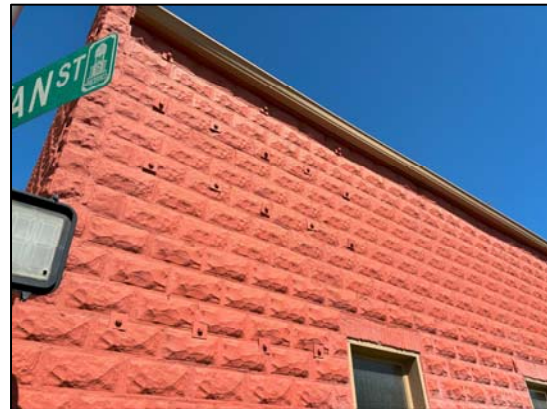
Photo 11: General view of the southeast corner and wall supports

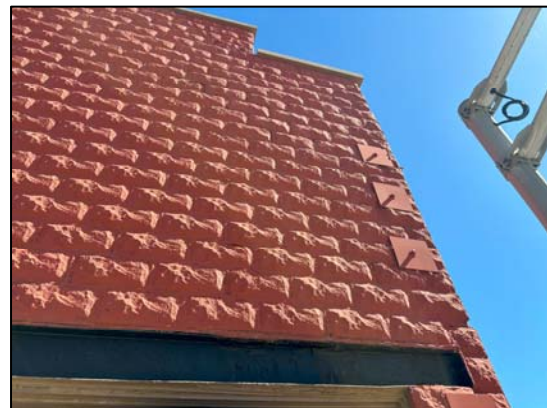
Photo 12: General view of the wall supports along the south wall

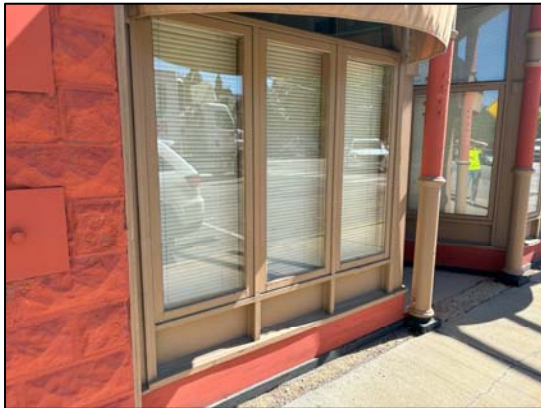
Photo 13: General view of the older wooden framed windows along the south wall

Recommendations: The building's wooden windows and the northwest door are still in functioning condition, but it is recommended that they be replaced with a newer commercial design to prevent water from continuing to enter the Subject Building. The sealant should also be replaced along all of the windows and the front entranceway to prevent possible water damage in the future.

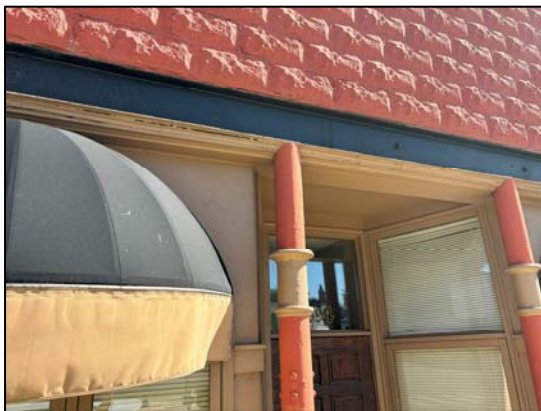
Photo 14: General view of the deteriorating sealant above the south wall windows

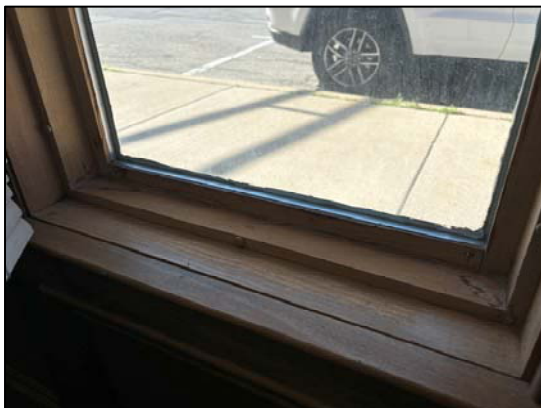
Photo 35: General view of the older wooden framed windows with water staining

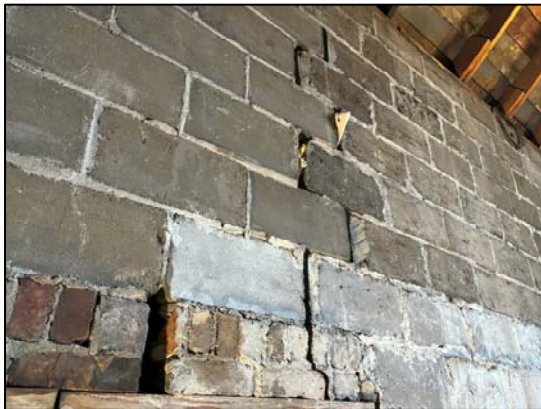
Photo 46: General view of cracked mortar and shifting blocks along the stairwell

Recommendations: Based on a visual survey, the overall structure of the Subject Building is in fair condition and will need repairs on the concrete blocks in the attic to prevent them from cracking and moving further apart. The ceiling in the basement will need to be repaired to prevent the upstairs floor from moving and also needs to be resealed to prevent further water from entering the basement. It is also recommended that a foundation company inspect the concrete block walls and concrete foundation to determine the full cost of possible repairs.

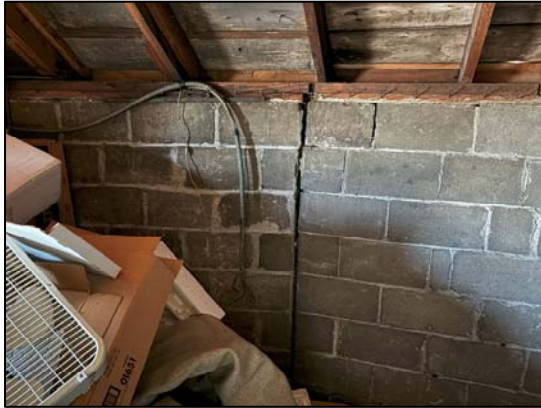
Photo 51: View of cracked and shifting concrete blocks in the northeast corner
