**RESOLUTION OF THE COMMON COUNCIL OF THE CITY OF NOBLESVILLE TO AFFIRM THE
ISSUANCE OF A CERTIFICATE OF AUTHORIZATION FROM THE PLAN COMMISSION FOR
DEMOLITION OF A STRUCTURE LOCATED AT 694 LOGAN STREET**

***Property
Condition Assessment***
(ASTM E 2018-15)

***Vacant Building
694 Logan Street
Noblesville, Indiana 46060***

Re: Property Condition Assessment
Vacant Building
694 Logan Street
Noblesville, Indiana 46060
APEC Project No.: 2024-288

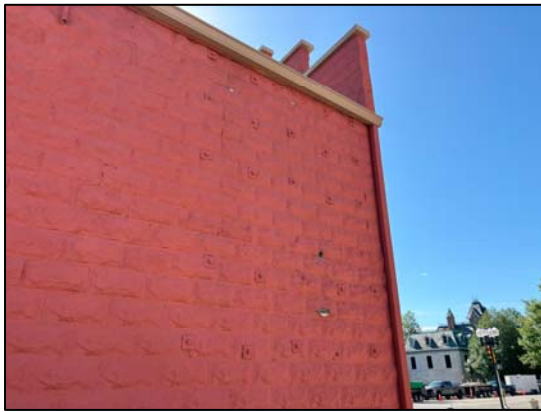
Recommendations: The exterior concrete block and mortar was observed to be in fair condition, except where the reinforcing wall plates were installed along the southwest, south, and southeast walls. The concrete blocks and mortar were actively cracking, and this is a sign that the building foundation is shifting or moving. It is recommended that a foundation company inspects the foundation integrity to determine whether more support is needed along the exterior wall.

Photo 2: General view of the southwest corner and wall supports

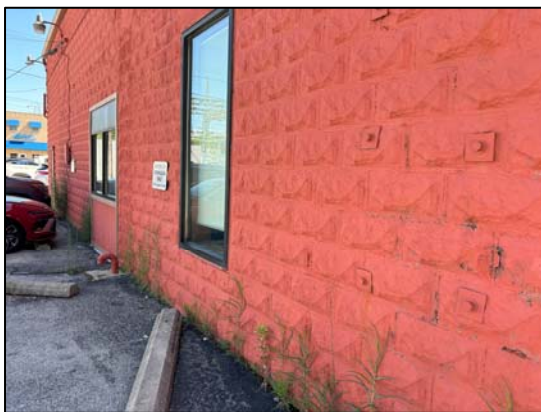
Photo 3: Another view of the southwest corner and wall supports

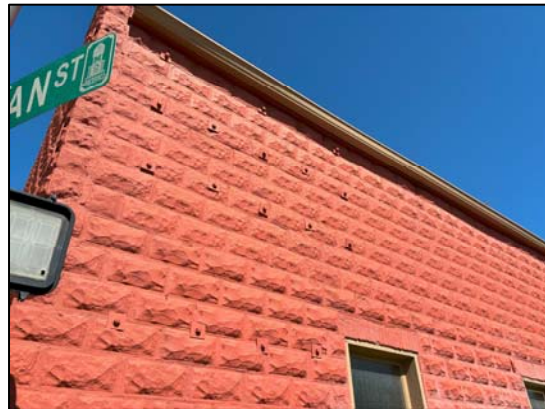
Photo 11: General view of the southeast corner and wall supports

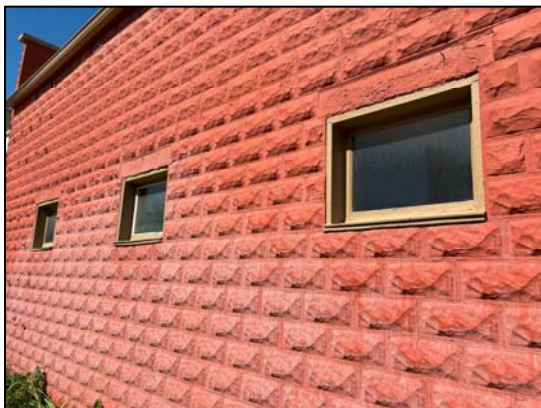
Based on a visual survey, the wooden door along the southside was in good condition and was sealed properly due to no observed water stains beneath the door. The wooden door located in the northwest corner of the building appeared to be improperly sealed because water stains were observed beneath the door frame. It was also observed that the wooden windows throughout the building had minor water stains along the bases of the windows, which would indicate that the seals are starting to deteriorate. The seal along the front entrance metal frame was also peeling and cracking, which could allow water to enter the Building (see photo 9 in Appendix A: Photo Log).

Photo 9: General view of the older wooden framed windows along the east wall

Recommendations: The building's wooden windows and the northwest door are still in functioning condition, but it is recommended that they be replaced with a newer commercial design to prevent water from continuing to enter the Subject Building. The sealant should also be replaced along all of the windows and the front entranceway to prevent possible water damage in the future.

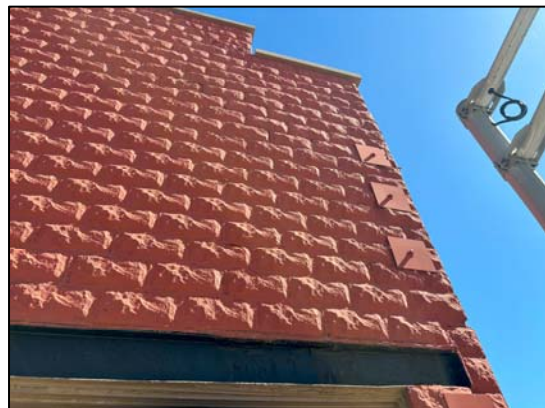
Photo 12: General view of the wall supports along the south wall

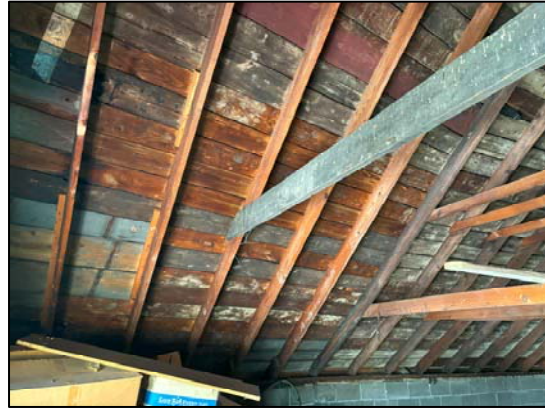
The Subject Building's roof is comprised of an asphaltic shingle material over top of old wooden boards. The roofing material appeared to be in fair condition throughout the roof and pitched at an adequate angle to the east and west to the integrated gutter system. It was observed that in some locations the shingles were beginning to peel up at the corners, and the wooden boards beneath the shingles were beginning to sag at certain locations. From inside the building's attic, visible gaps were observed between the top sill plate and concrete block walls and the roofing frame that meets the south concrete block wall (see photos 5 and 6).

Photo 20: General view of the old wooden boards beneath the shingles

Recommendations: Based on a visual inspection, the roofing material itself was in fair but functioning condition and should be replaced in the near future to prevent further water damage. The boards beneath the shingles should also be replaced where they are beginning to sag to prevent the roof from breaking or allowing water to enter the building. The roof will need to be properly sealed to the concrete block walls to prevent further water damage and animals from entering the building.

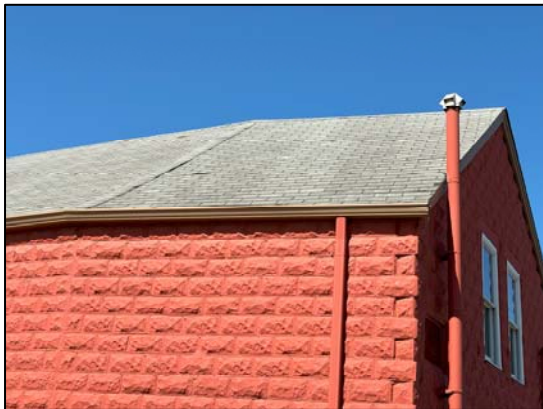
Photo 18: Another view of the roof and sagging in the northeast corner

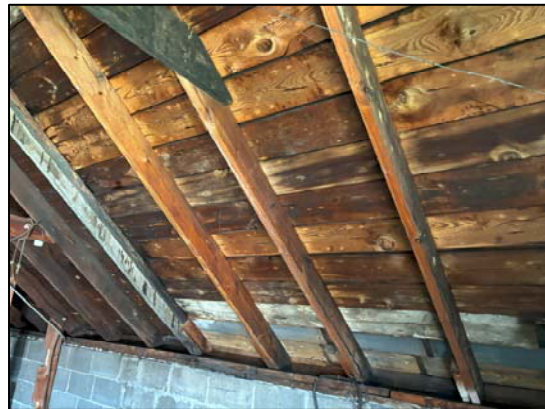
Photo 21: Another view of the older wooden boards with starting signs of deterioration

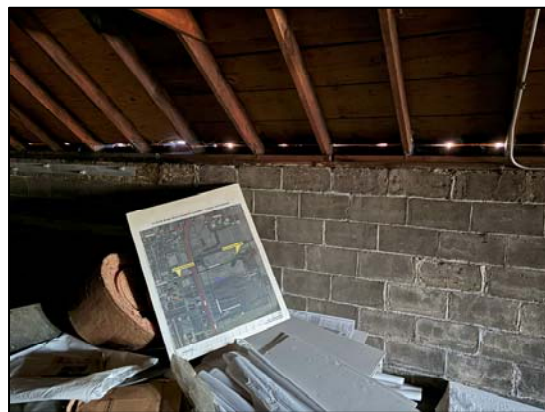
Photo 22: View of improperly sealed soffit along the roof and wall line

Recommendations: The soffits and eaves around the office building are unlikely to need immediate repairs in the near future, but it is recommended that the soffit be replaced with newer soffit to prevent animals from entering the attic and also provided proper ventilation.

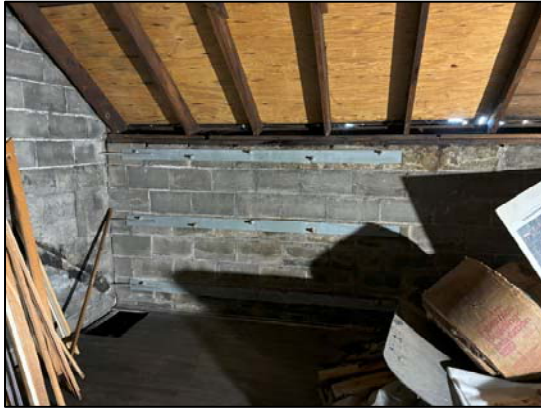
Photo 23: Another view of improperly sealed soffit along the roof and wall line

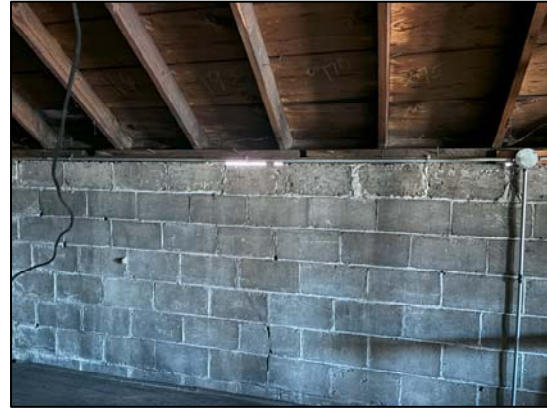
Photo 25: View of the improperly sealed boards to the top of the concrete block wall

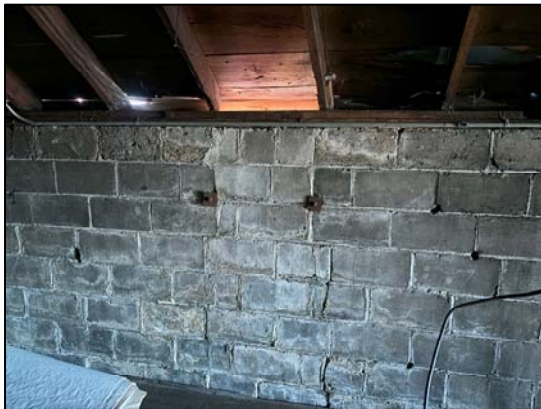
Photo 24: Another view of improperly sealed soffit along the roof and wall line

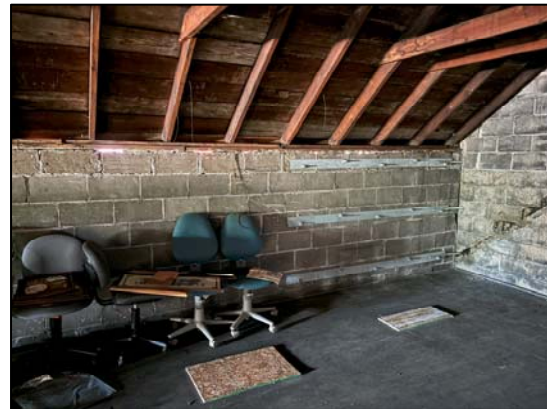
Photo 26: Another view of the improperly sealed boards to the top of the concrete block wall

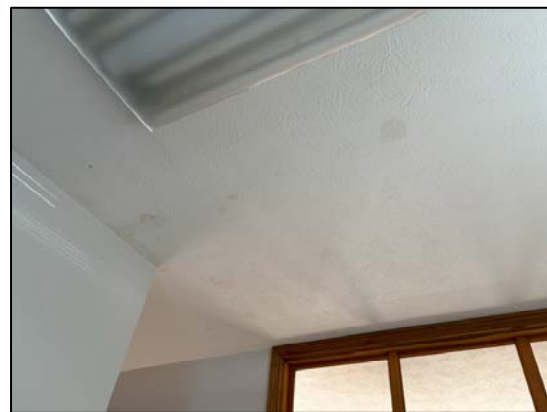
Interior construction of the drywall was overall in fair condition throughout the hallways and offices. There were minor scuffs and holes observed throughout the first floor, and minor water stains were observed along the southern ceiling section. The concrete block within the upstairs storage room appeared to be in fair condition with visible cracks and gaps within the mortar. The concrete blocks upstairs were not sealed and the concrete foundation with the basement was also unsealed.

Photo 32: View of the water stained ceiling in the south section of the first floor

Recommendations: Based on a visual survey, the interior construction of the Subject Building was in fair condition. It is recommended that the drywall be patched and replaced throughout the first floor where holes and water staining are observed. The hardwood floors upstairs need to be properly replaced where the holes were just patched with a board. The upstairs concrete blocks need to be supported to prevent further movement and also sealed to prevent any deterioration.

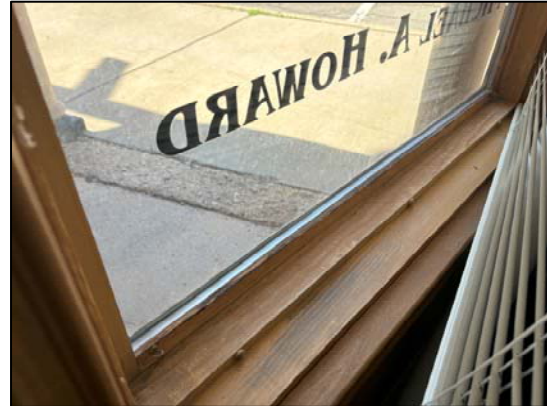
Photo 36: Another view of the older wooden stained windows with water staining

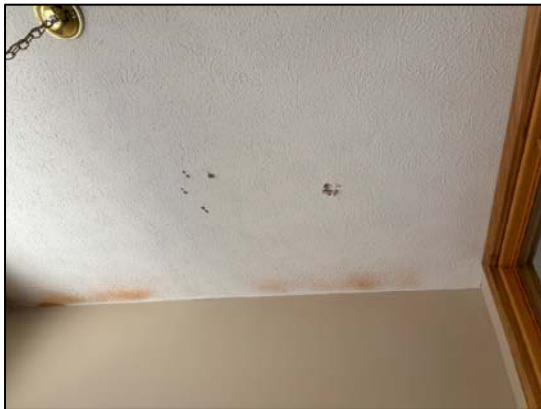
Photo 34: View of damaged drywall ceiling in the front lobby

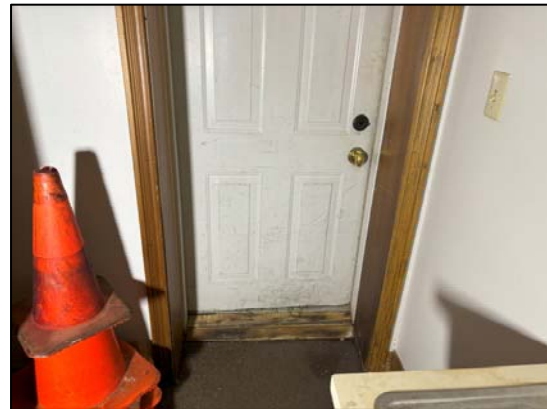
Photo 43: General view of the northwest entrance and water-stained boards beneath

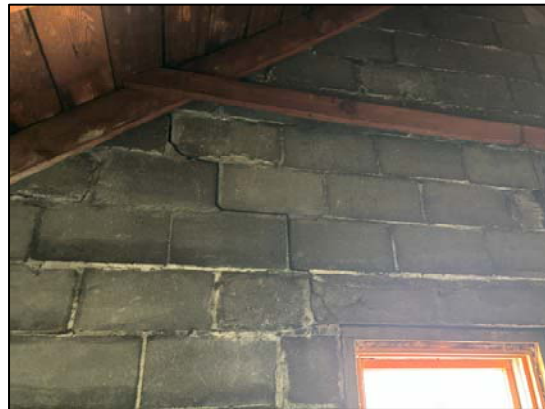
Photo 49: View of cracked concrete mortar along the northern windows

Recommendations: Based on a visual survey, the overall structure of the Subject Building is in fair condition and will need repairs on the concrete blocks in the attic to prevent them from cracking and moving further apart. The ceiling in the basement will need to be repaired to prevent the upstairs floor from moving and also needs to be resealed to prevent further water from entering the basement. It is also recommended that a foundation company inspect the concrete block walls and concrete foundation to determine the full cost of possible repairs.

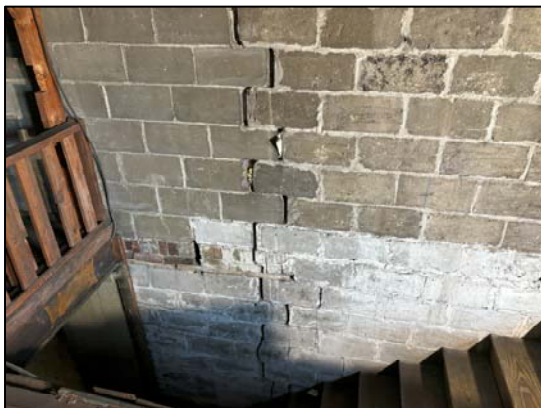
The upstairs attic consists of concrete block walls and wooden supports for the frame of the roof. Overall, the wooden supports appeared to be in fair condition with minimal signs of rot or deterioration. The concrete blocks were in fair condition because they were not cracking, but there were multiple observed gaps in the mortar between adjoining concrete blocks.

Photo 47: Another view of cracked mortar and shifting blocks along the stairwell

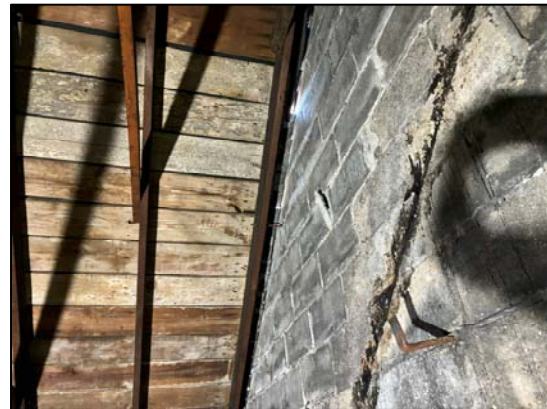
Photo 55: View of an improperly sealed roof

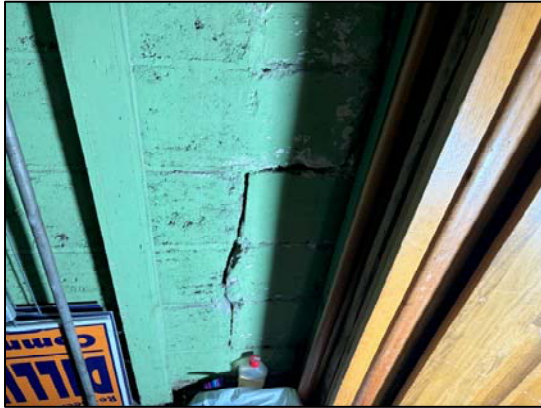
The basement consisted of a poured concrete floor slab and walls, and wooden supports for the ceiling. The concrete floor slab had visible cracking in the floor, and the concrete foundation had multiple areas where the concrete had cracked away from the wall. Water-stained lines were observed along the west and south walls where water had infiltrated into the Building. The water infiltration appeared to be deteriorating the concrete foundation and also the wooden floor supports in the west and south sections. It was also observed that the ceiling was braced with multiple supports to prevent the floor from sagging or moving.

Photo 57: General view of cracked mortar along the basement stairwell

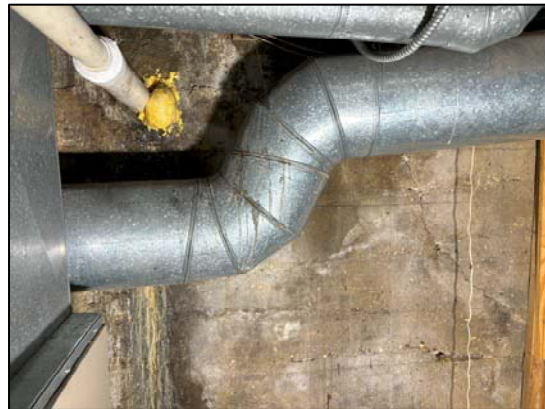
Photo 61: General view of the water stained wall behind the HVAC system

Recommendations: In the basement the active mold growth will need to be properly removed with a fungicide or by a specialized company to prevent further growth and deterioration of the support boards in the basement. The exterior walls should also be properly sealed to prevent moisture from entering the Building and facilitating the mold growth.

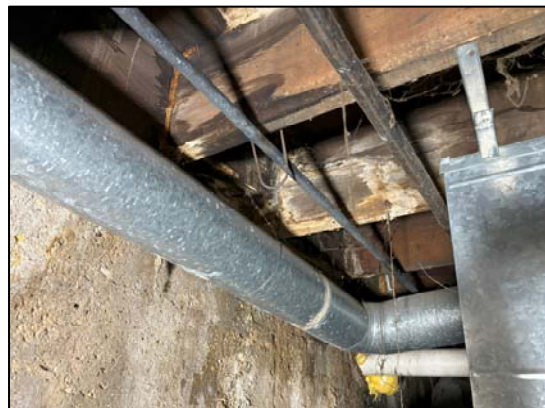
A visual mold inspection was performed, and it was observed that the runner boards in the basement ceiling had active mold growth in the southern section. (see photo 29 in Appendix A: Photo Log).

Photo 62: General view of water stained floor boards with mold growth

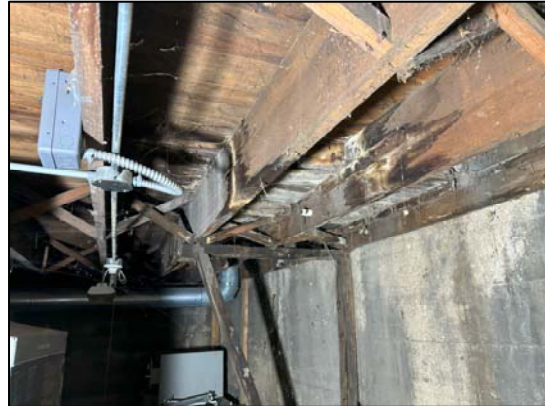
Photo 66: Another general view of water stained floor boards and mold growth

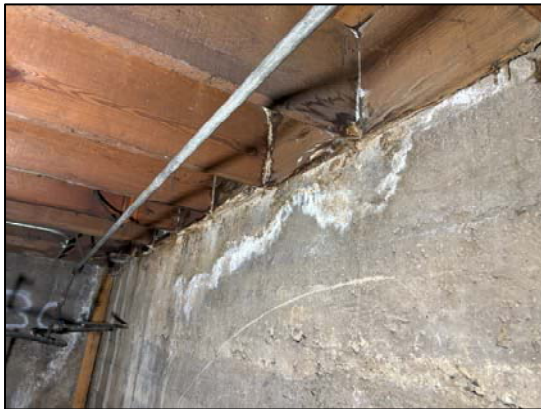
Photo 64: Another view of water-stained walls and mold growth in the southwest corner

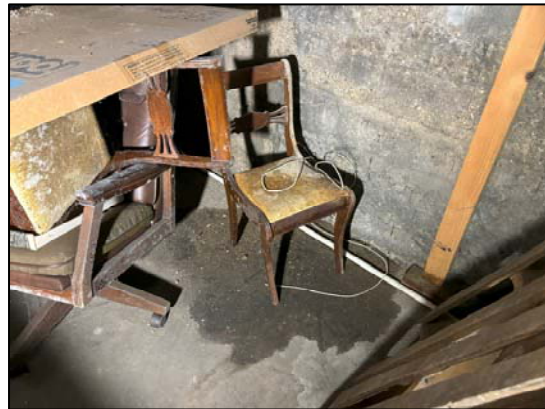
The flooring materials throughout the building were in fair condition. The carpet did not have major peeling or tearing throughout the offices, but some water stains were visible from the northwest door. The hardwood floor in the upstairs storage room was in fair condition with normal wear and tear, but the holes cut in the floor had been patched with pieces of wood. The concrete slab within the basement had cracking throughout, and it appeared to be unsealed concrete.

Photo 67: General view of the water stained floor slab

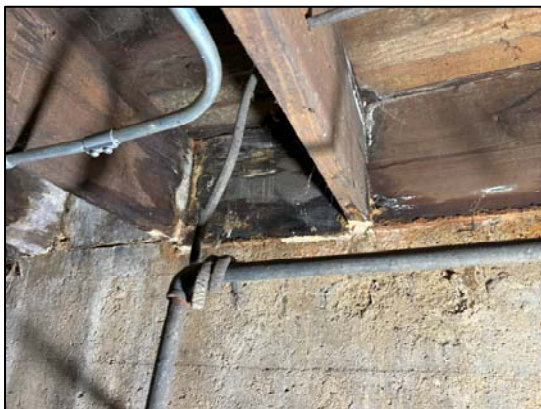
Photo 65: Another view of mold growth and deteriorating floor boards

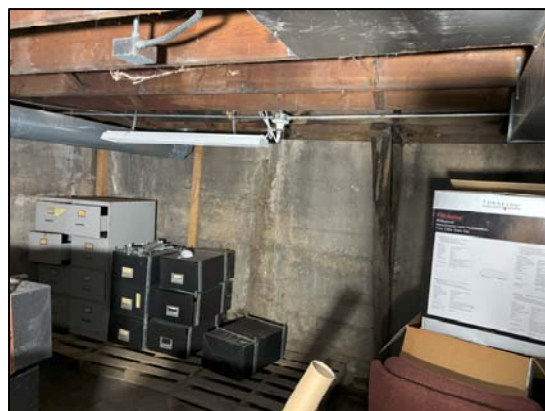
Photo 68: General view of the south wall and water stains along it
