**TO: BOARD OF PUBLIC WORKS AND SAFETY**  
**FROM: AARON HEAD, COMMUNITY ENGAGEMENT MANAGER**  
**SUBJECT: 1179 CONNER STREET – RESIDENTIAL FAÇADE GRANT**  
**DATE: AUGUST 20, 2024**

## **Residential Façade Improvement Grant Application**

# 1179 Conner Street Facade Grant Application

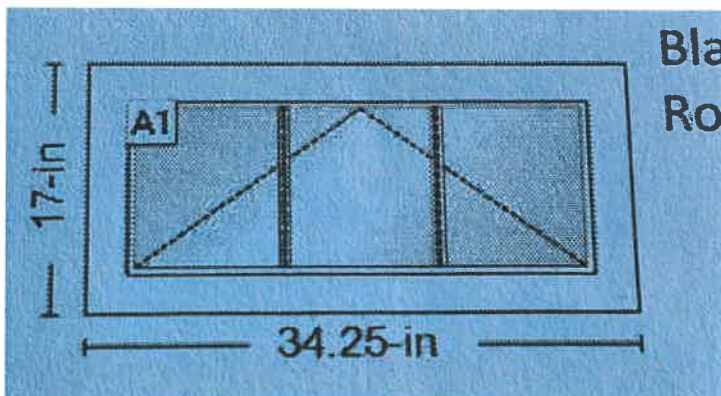
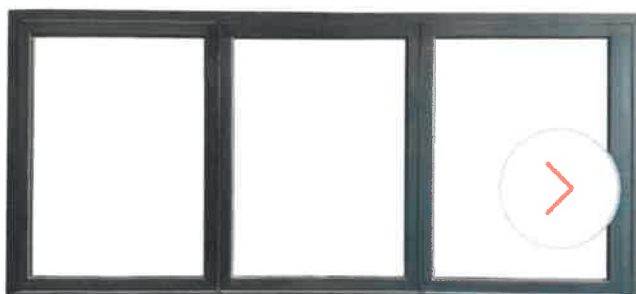
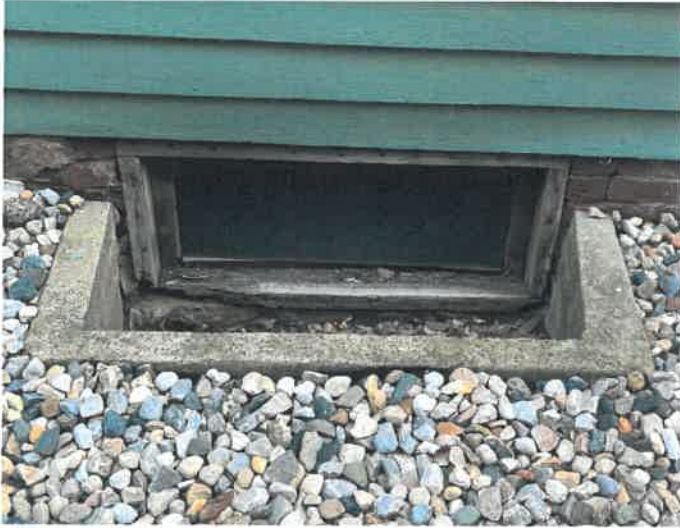
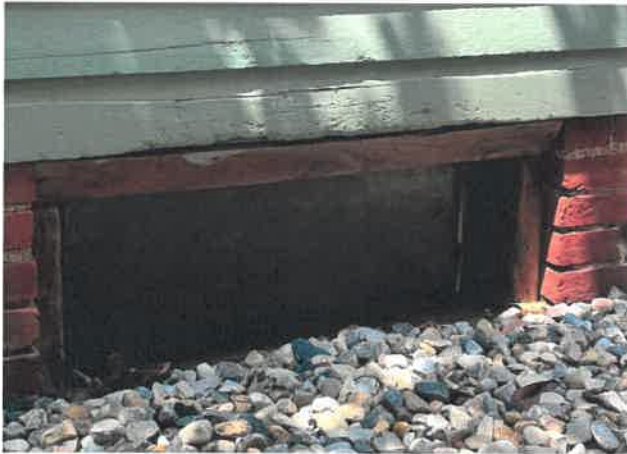
#### 1. Replace 2 basement windows

- a. Current condition:
  - i. Rotted wood and cracked glass cause leaking into basement
- b. Work description:
  - i. Install custom, vinyl windows. Vinyl trim will be black to match existing window style.
  - ii. Measurement for custom window below and screenshot is of a similar (not exact same) window.

c. Historic photos - none available from this angle

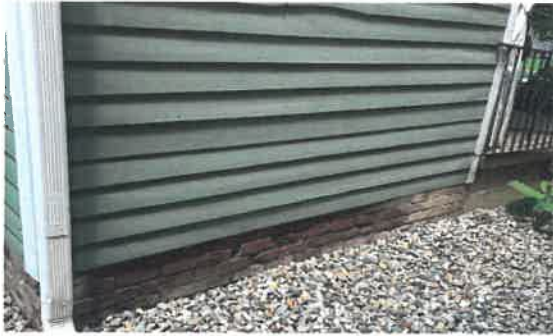
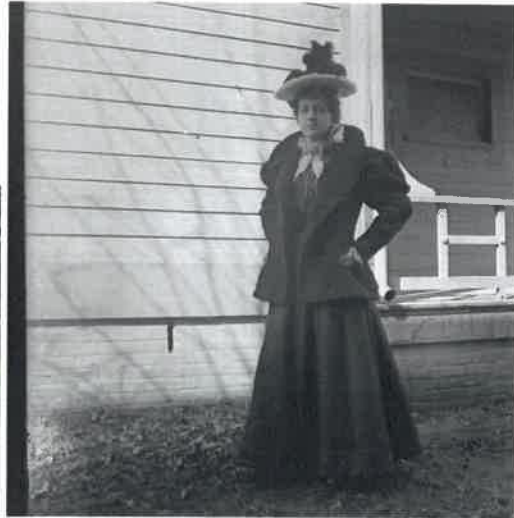
**2. Brick & mortar repairs on East side of foundation including replacing block window with brick and mortar, replacing spray foam, and refreshing wear and tear**

- i. Block window is no longer sealed which causes water to leak into basement
- ii. Spray foam (instead of mortar) also causes water leaks.

- i. Masons will grind out cracked, depreciated mortar joints using a diamond blade to create a new bonding surface. Tuck point grounded out mortar joints using matching mortar to the original (as best as possible). Reset and insure bricks are not loose and are secure throughout.

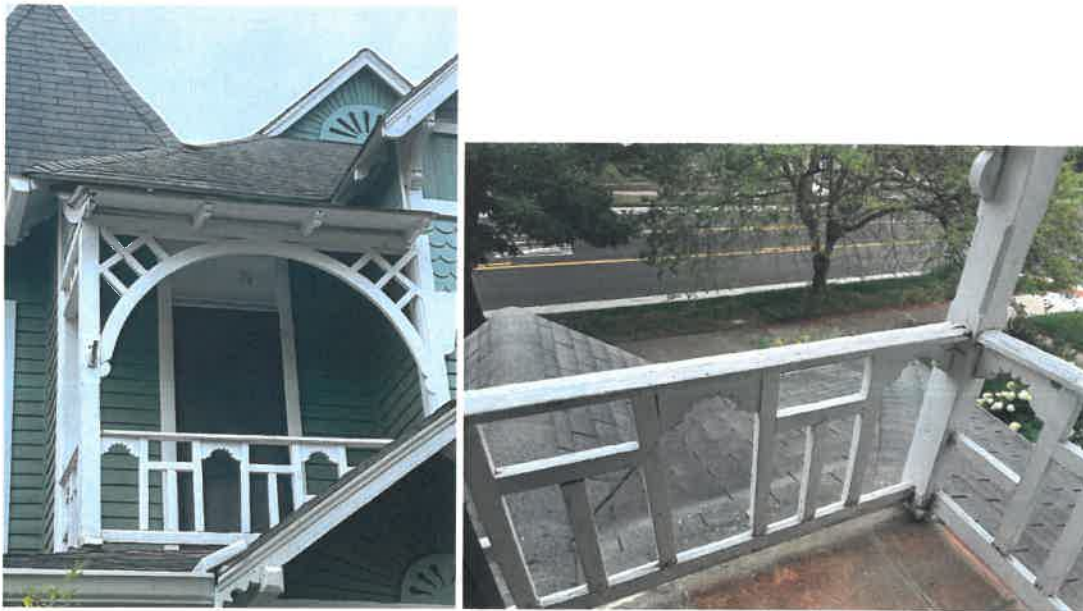
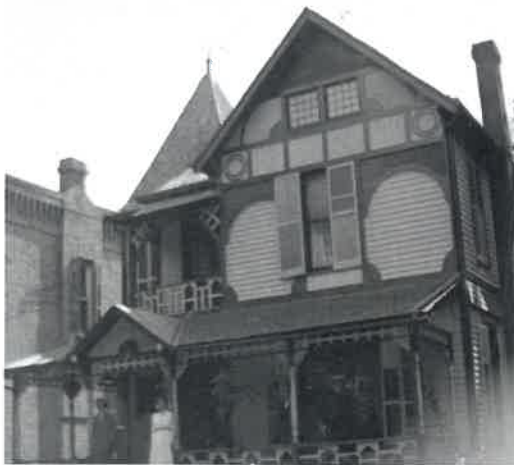
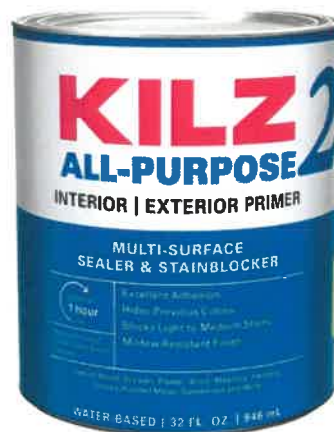
### **3. Repair structural issues/wood rot on second story balcony**

- i. Upper balcony post and railing have wood rot and post has started to sink.
- ii. Railing is also very low causing safety concerns

- i. Cut rot from bottom of post and replace with a material that is rot resistant (preferably a historically accurate decorative metal foot if available). Increase railing height to code. Railing will require cutting in half to add a small section of wood to make it wide enough to properly fit the span. The new section of wood will be joined by wood glue and stainless steel pocket screws which will be hidden with a wooden biscuit. The new wood will be shaped to match the profile of the existing railing and then the entire railing will be painted to match the existing white color.

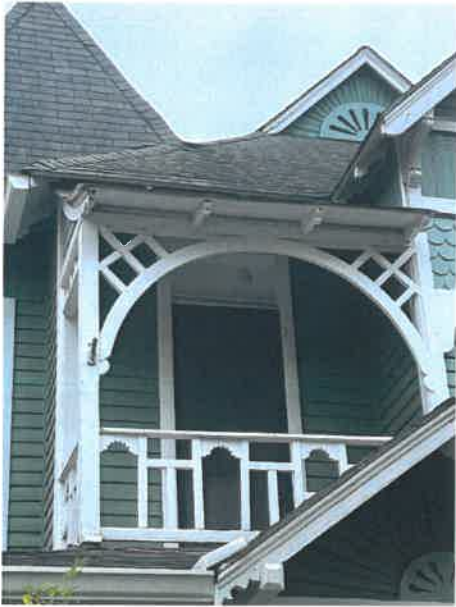
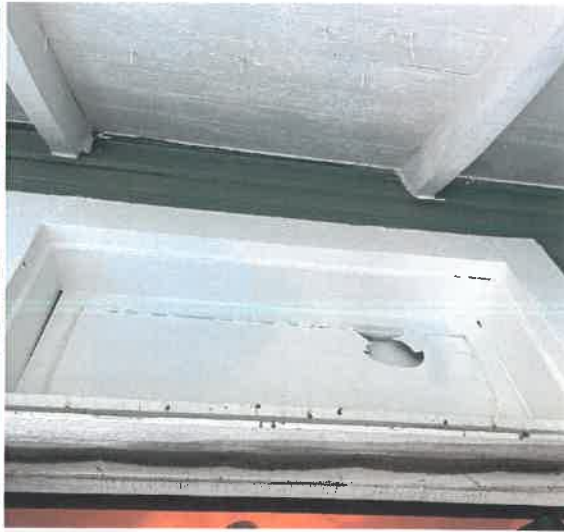
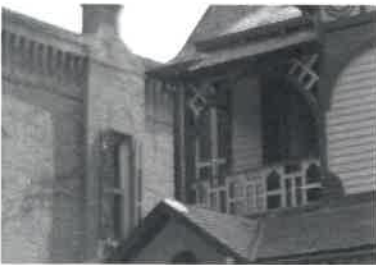
#### **4. Reveal transom window above second story balcony door**

- i. Transom window has been covered with plywood and a portion of that coverage has a hole in it – this is unsightly and hides an attractive feature of the home.

- i. Remove plywood and install glass in transom. Glass will be single pane 1/4 inch glass held by glazing pins and glaze (exactly how the original glass would have been installed)

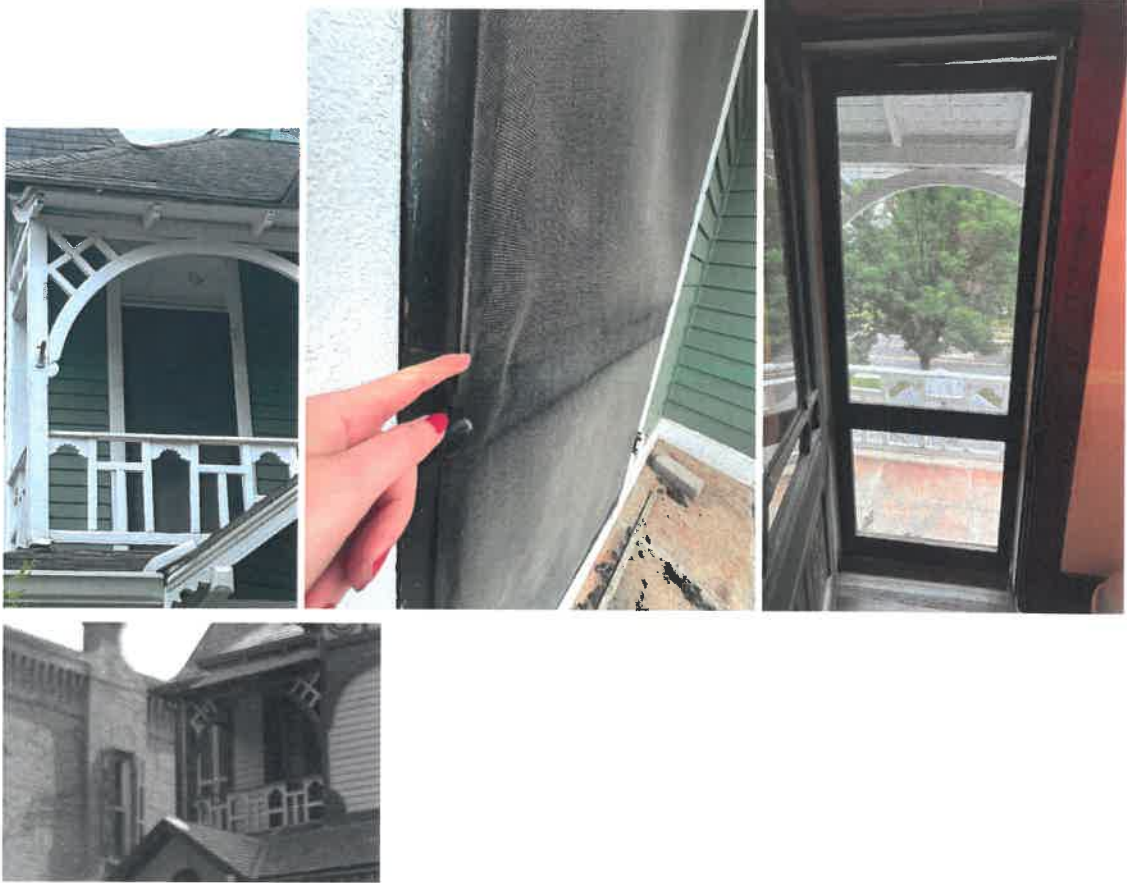
## **5. Repair second story balcony screen door**

- i. Screen material has tears. It is loosely stapled to the door and door doesn't fit the full door frame making it unusable due to bugs/weather getting in.**

- i. Replace screen with fiberglass material held by staples which will be hidden by strips of wood made to match wood of existing door. Also work on door to get it to shut properly where it is not touching the door frame.**

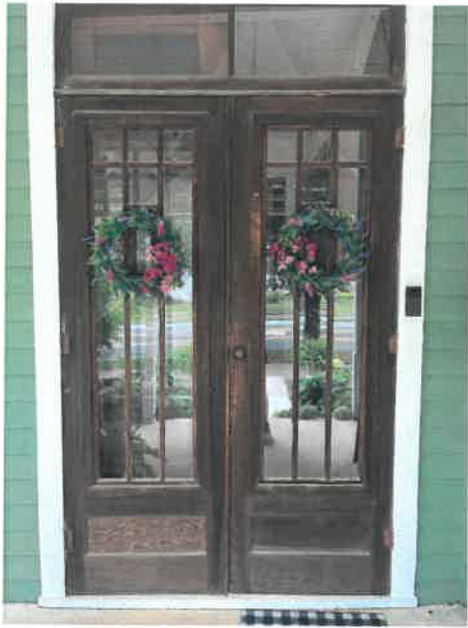
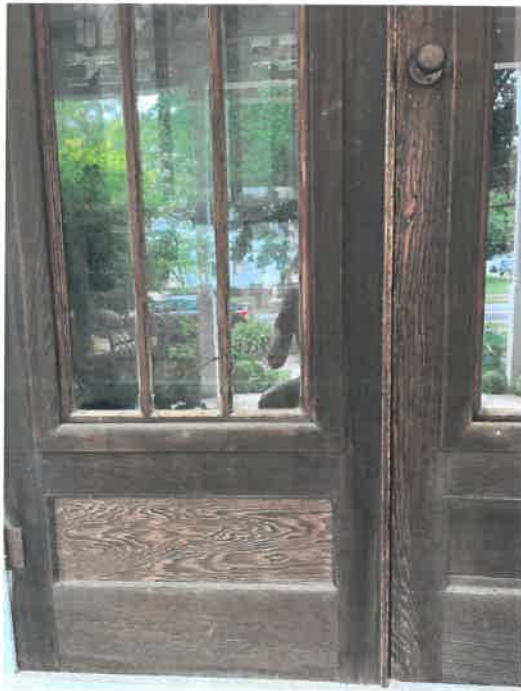
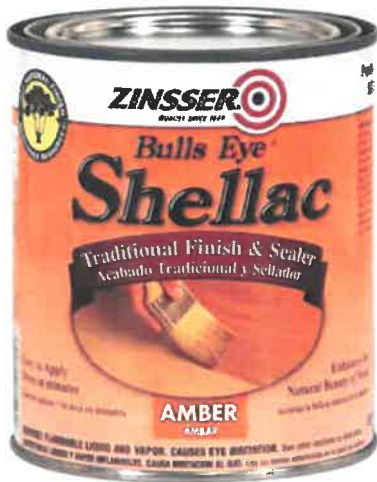
**6. Refinish front door**

- a. Current condition:
  - i. Wear and tear
- b. Work description:
  - i. Refinish front doors by lightly sanding all surfaces and finishing with using Zinsser Bulls Eye Amber Shellac (this product would be closest to what was originally used when the house was built and will look authentic after being brushed on in several coats).
