RE: 694 Logan Street Building Application for Demolition Permit

*Property
Condition Assessment
(ASTM E 2018-15)*

*Vacant Building
694 Logan Street
Noblesville, Indiana 46060*

Re: Property Condition Assessment
Vacant Building
694 Logan Street
Noblesville, Indiana 46060
APEC Project No.: 2024-288

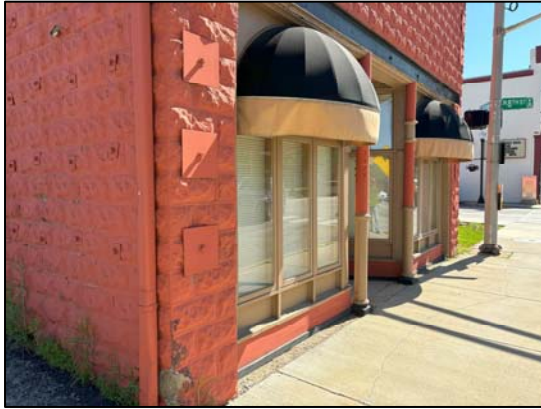
Photo 1: General view of the Subject Building

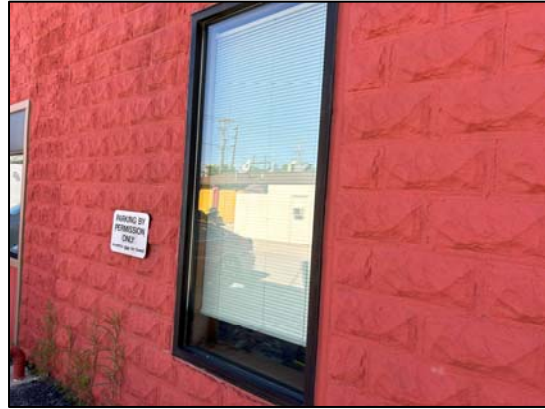
Photo 4: General view of the new commercial windows

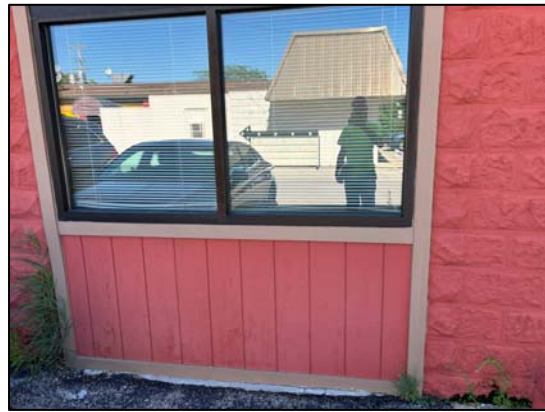
Photo 5: Another view of the new commercial windows

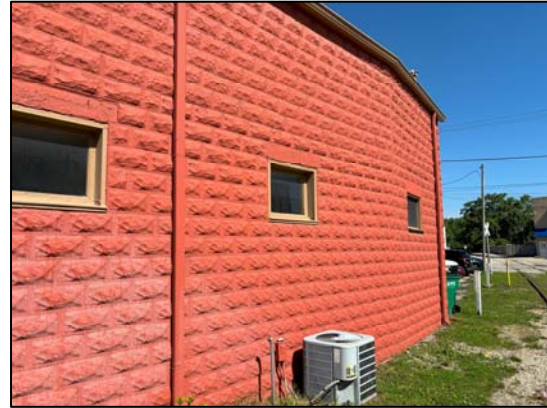
Photo 10: General view of the air conditioning unit outside

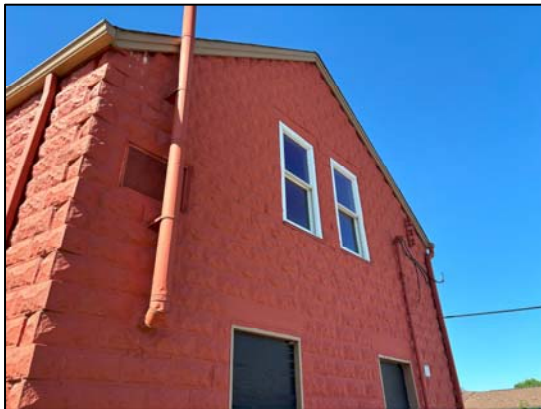
Photo 8: General view of the ventilation pipe

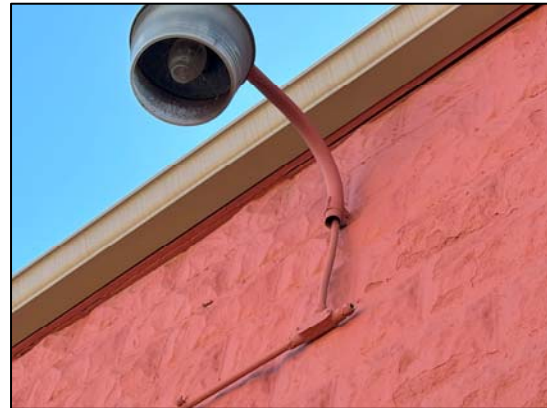
Photo 16: General view of an old light fixture along the west wall

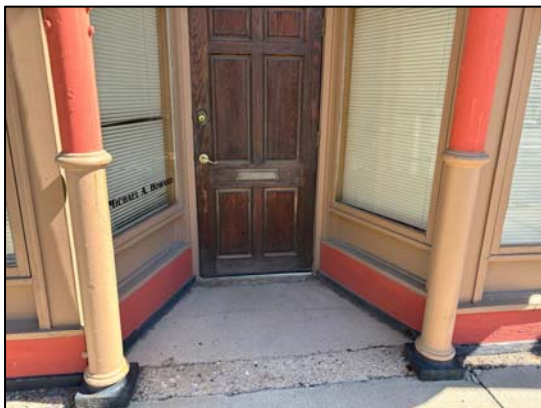
Photo 15: General view of the south main entrance

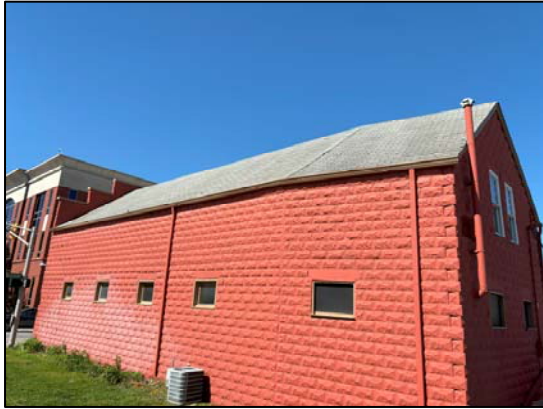
Photo 17: General view of the roof along the east side of the Building

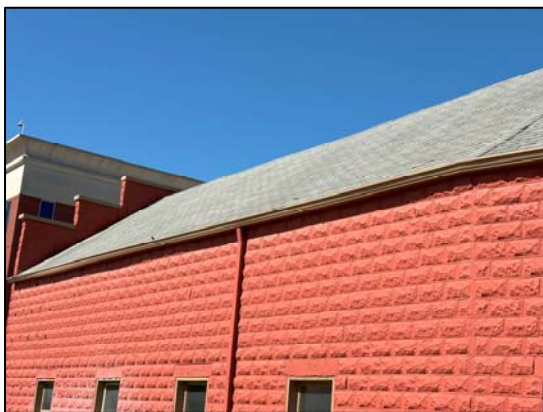
Photo 19: General view of the gutter system along the east wall

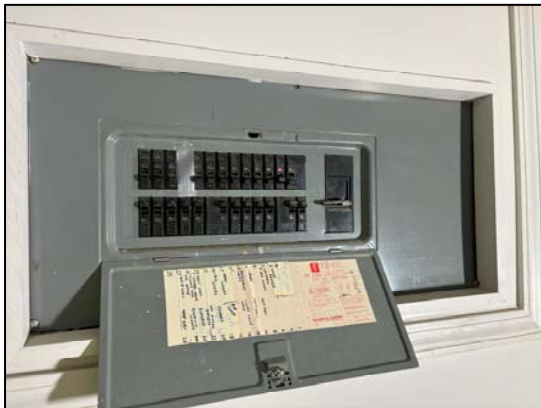
Photo 41: View of the electrical panel within the wall of the bathroom

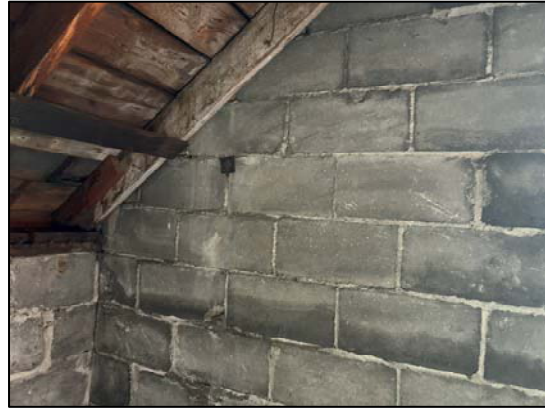
Photo 48: General view of a wall support in the northwest corner of the Building

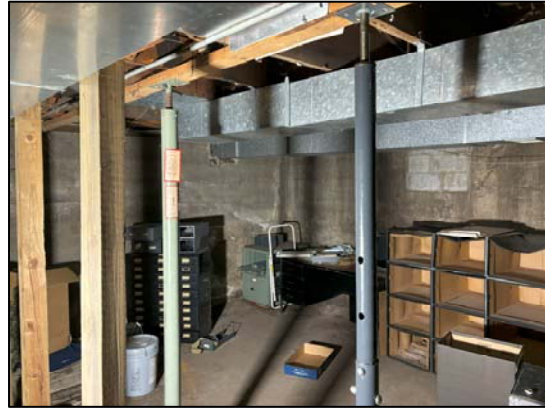
The basement consisted of a poured concrete floor slab and walls, and wooden supports for the ceiling. The concrete floor slab had visible cracking in the floor, and the concrete foundation had multiple areas where the concrete had cracked away from the wall. Water-stained lines were observed along the west and south walls where water had infiltrated into the Building. The water infiltration appeared to be deteriorating the concrete foundation and also the wooden floor supports in the west and south sections. It was also observed that the ceiling was braced with multiple supports to prevent the floor from sagging or moving.

Photo 60: General view of the support beams holding the floor up

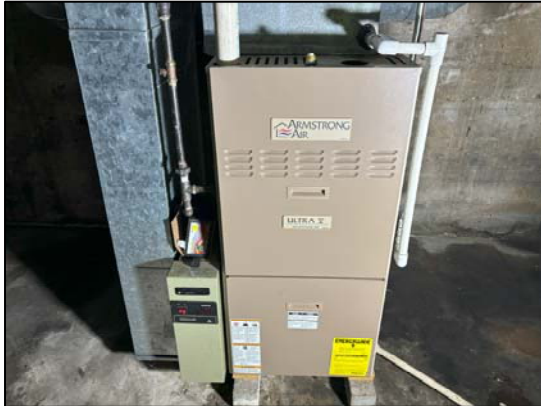
Photo 63: General view of the HVAC system within the basement

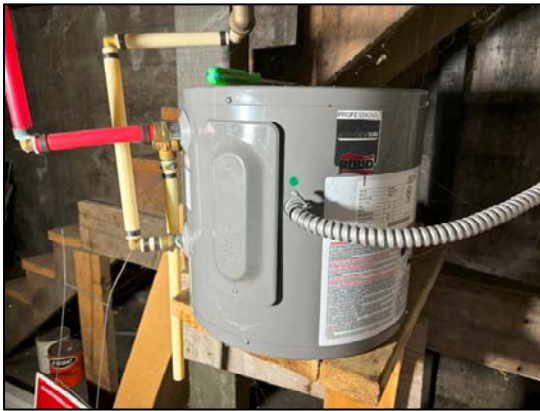
Photo 70: General view of the hot water heater along the stairwell
