**RESOLUTION OF THE COMMON COUNCIL OF THE CITY OF NOBLESVILLE TO AFFIRM THE
ISSUANCE OF A CERTIFICATE OF AUTHORIZATION FROM THE PLAN COMMISSION FOR
DEMOLITION OF A STRUCTURE LOCATED AT 694 LOGAN STREET**

***Property
Condition Assessment***
(ASTM E 2018-15)

***Vacant Building
694 Logan Street
Noblesville, Indiana 46060***

Re: Property Condition Assessment
Vacant Building
694 Logan Street
Noblesville, Indiana 46060
APEC Project No.: 2024-288

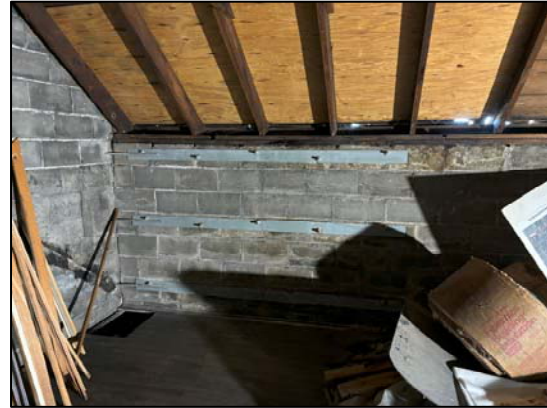
Photo 54: View of wall supports along the southwest wall

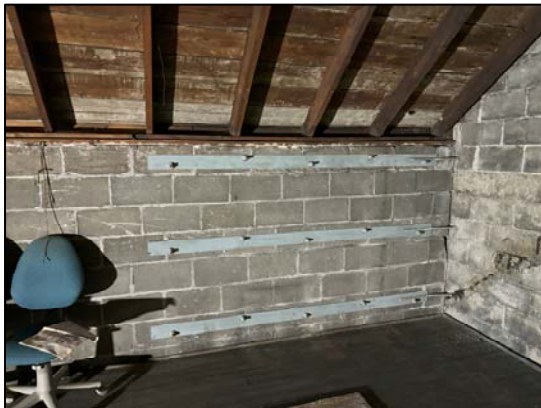
Photo 53: View of wall supports along the southeast wall

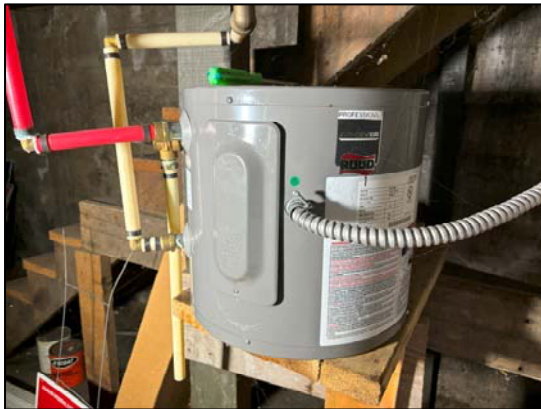
Photo 70: General view of the hot water heater along the stairwell
