RE: 694 Logan Street Building Application for Demolition Permit

*Property
Condition Assessment
(ASTM E 2018-15)*

*Vacant Building
694 Logan Street
Noblesville, Indiana 46060*

Re: Property Condition Assessment
Vacant Building
694 Logan Street
Noblesville, Indiana 46060
APEC Project No.: 2024-288

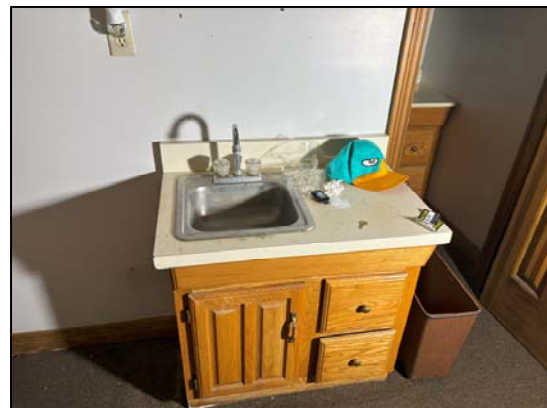
Photo 38: View of the north sink outside of the bathroom
